# 1 1/2" diameter galvanized vent pipe

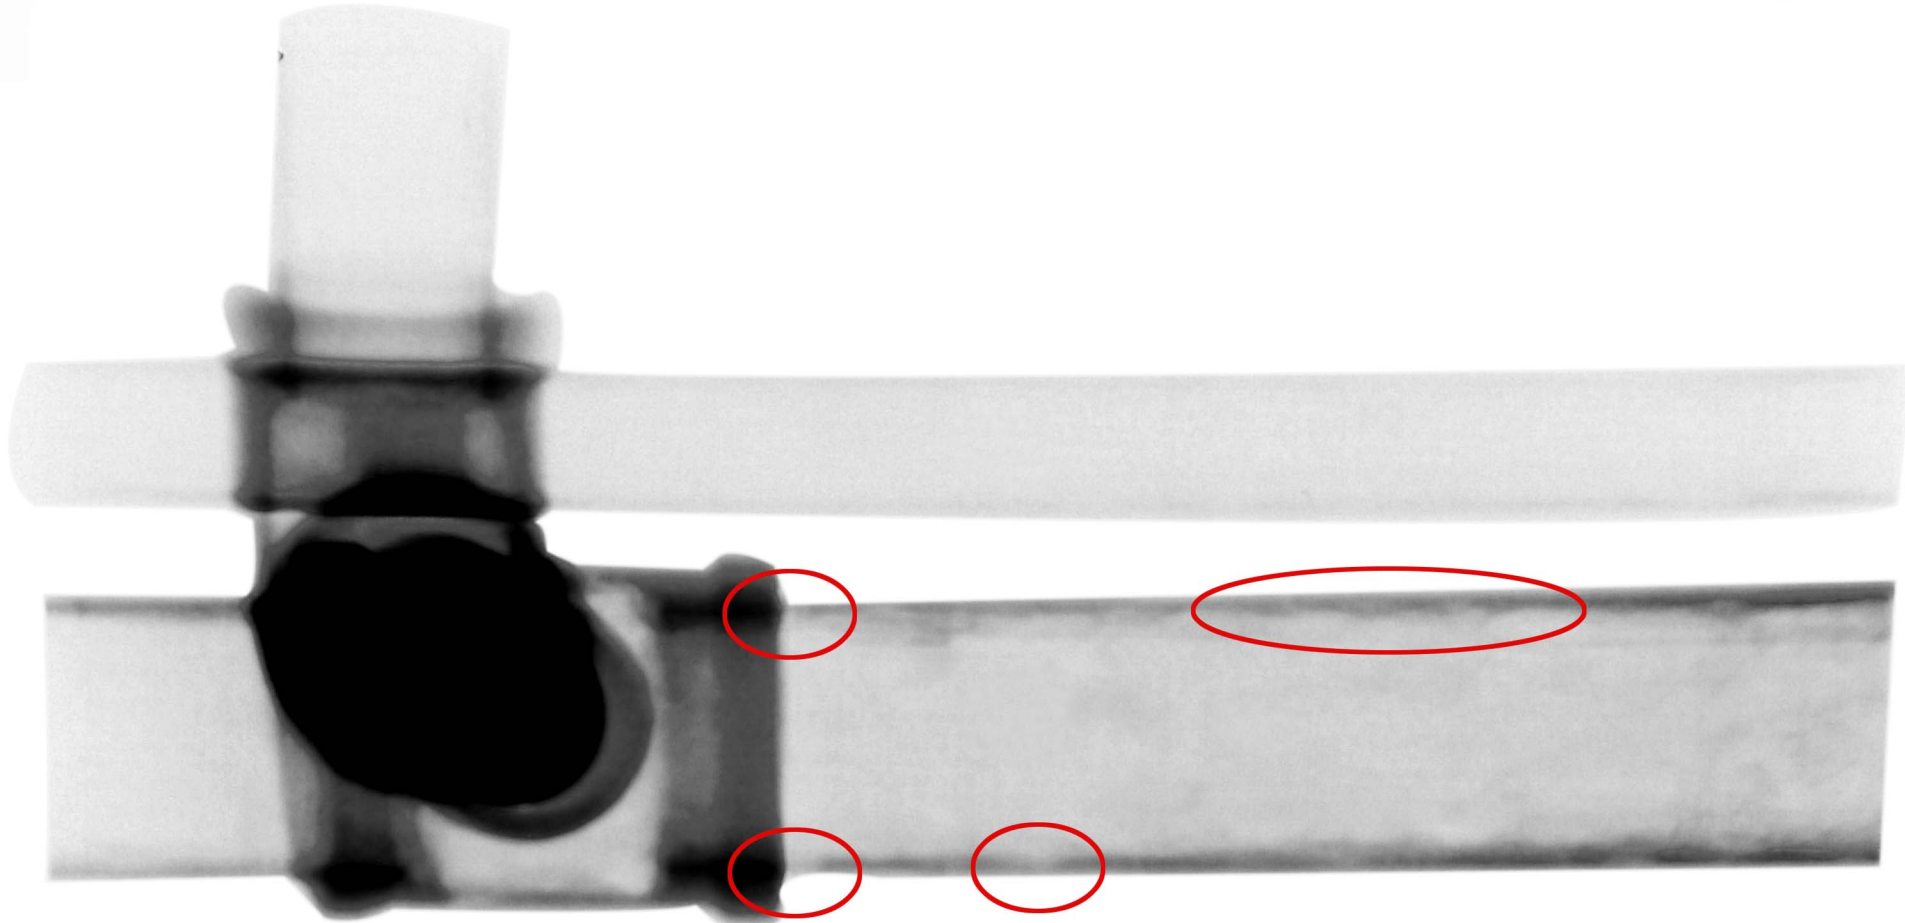
- Severe pitting on the inside pipe wall
- Thinning at the threaded tee fitting (60+%)
- The inside of the pipe is covered with scale mound which takes up 20 to 30% of the interior surface
- The pipe wall is thinned by 80% in some areas...corrosion scale is providing what little wall strength that remains. Any sudden shock such as draining the pipe could cause a thread failure
- Scale has reduced flow by 40%
