- X-Ray no.76 : Mechanical Room
- 4 in. x 2 1/2 in. x 3 in. bushing
- 2 1/2 in. nipple Cold water
- Leaks at 2 1/2 in. nipple at wall

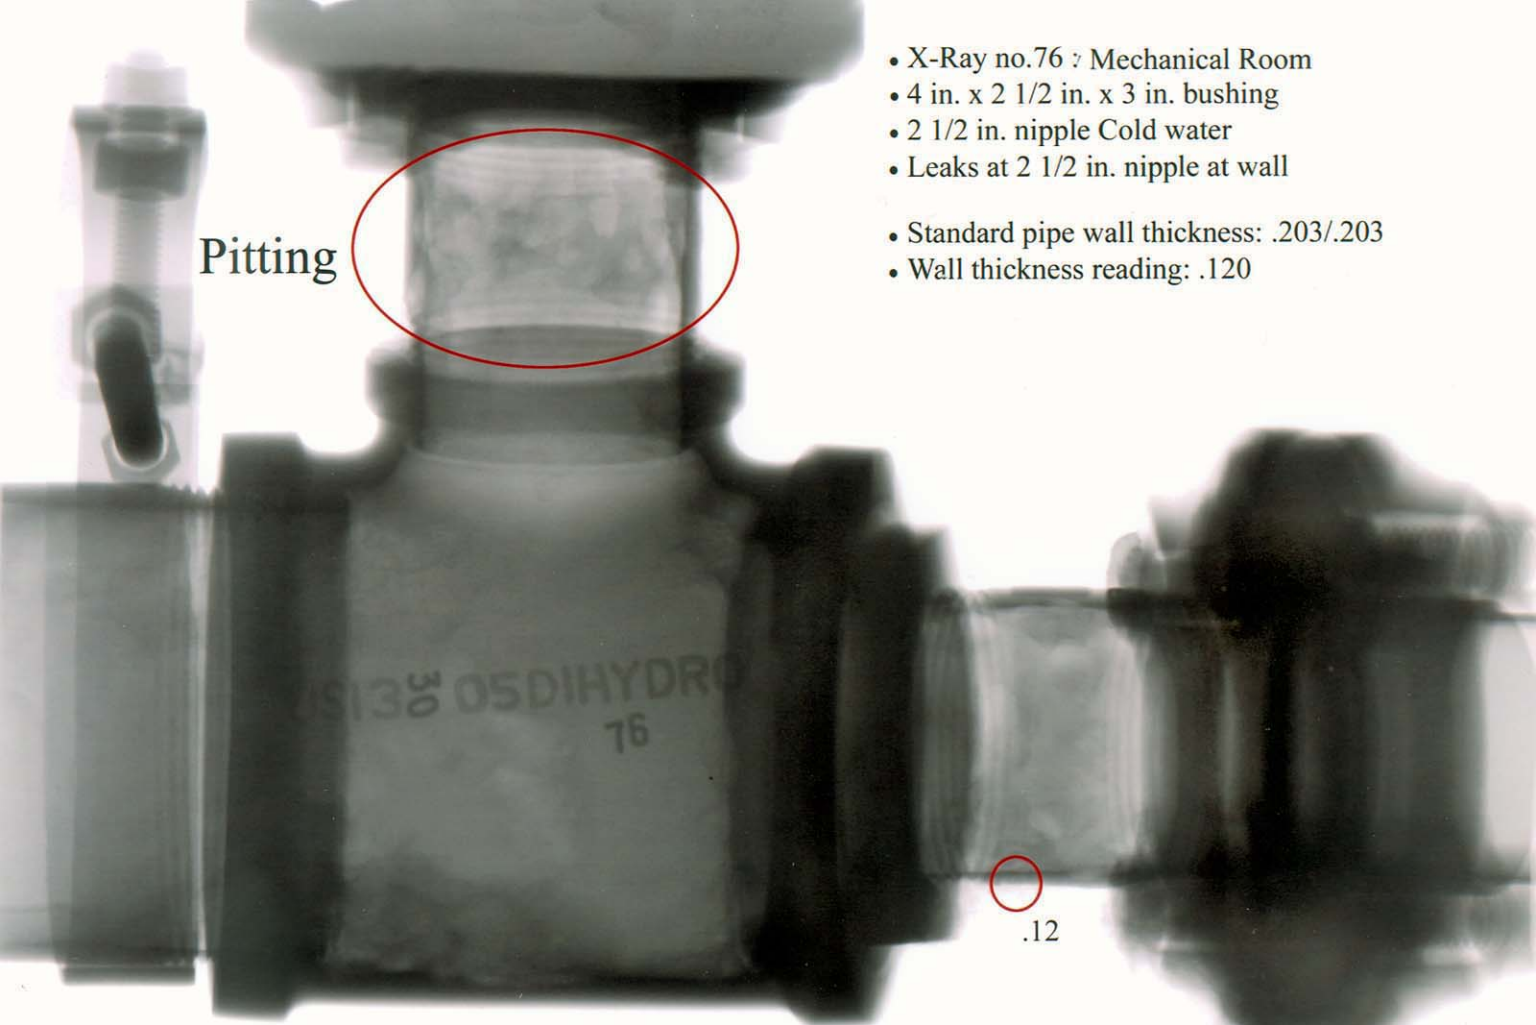
- Standard pipe wall thickness: .203/.203
- Wall thickness reading: .120

- Leak at the 2 1/2 in. nipple wall penetration
- 3 in. diameter bushing wall loss 40-65%
- Nipple wall is penetrated and leaking
- Scale covers the I.D.
- This section needs to be repaired
