DIHYDRO/USI
15 02 P

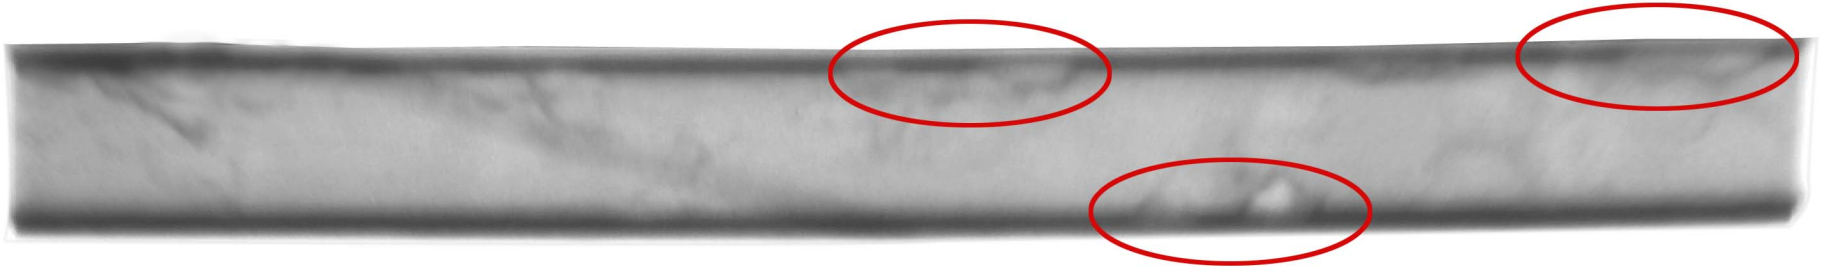
1" galvanized domestic hot water return, low level

1 1/2" galvanized domestic hot water supply

1 1/4" carbon steel hot water heating return

- Serious pitting under mounds of existing scale extending from the pipe surface .062" to .375"...restricting flow by 30%
- This X-ray image shows three major pits in the pipe wall 55 to 85%
